City of Clyde Hill
Council Study Session

3.1. Update of Property Evaluation on Fire Station #5
[Clyde Hill Facilities Assessment](#)

RE Clyde Hill
City Hall and Maintenance Building Existing Conditions Review

Mechanical Systems Survey

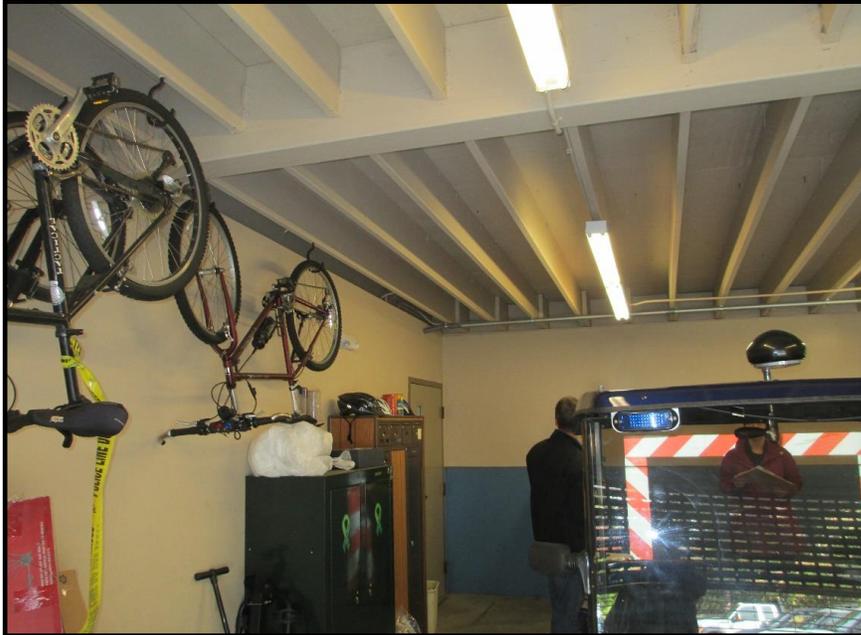
Photo 5: City Hall – Sally Port Roof Framing

3. The roof diaphragm has many steps creating load path issues for the seismic forces.
RECOMMENDATION: Add additional connections and strut beams at roof steps to tie the building together better and distribute loads during a seismic event.

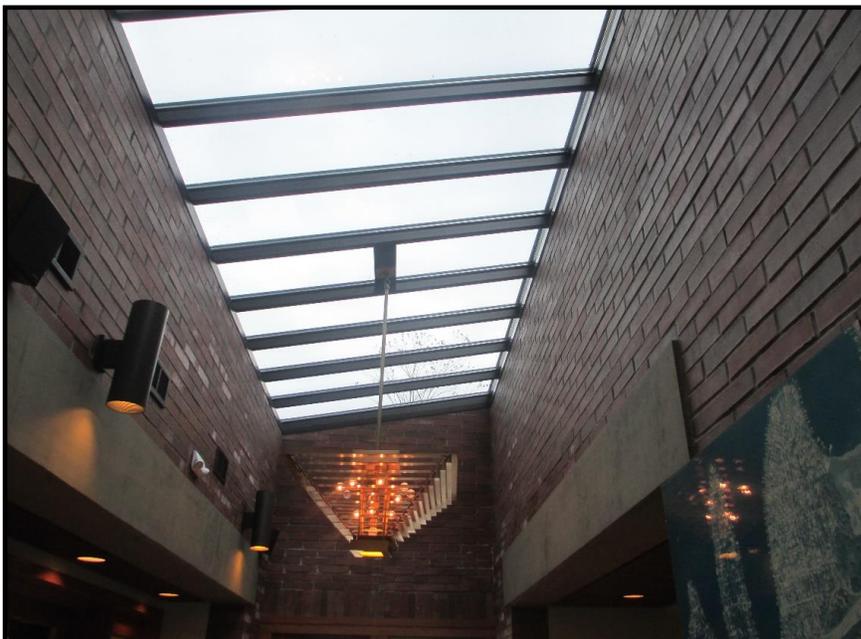
Photo 6: City Hall – Lobby Skylight

4. There are two large skylights in the lobby and corridor area which creates a big discontinuity in the roof diaphragm. This creates a risk for the seismic loads to not be transferred to shear walls and also is risk for the building to be damaged from moving separately during a seismic event.
RECOMMENDATION: Add strut beams across the opening to transfer seismic forces between the two sides and keep the two sides of the building tied together.

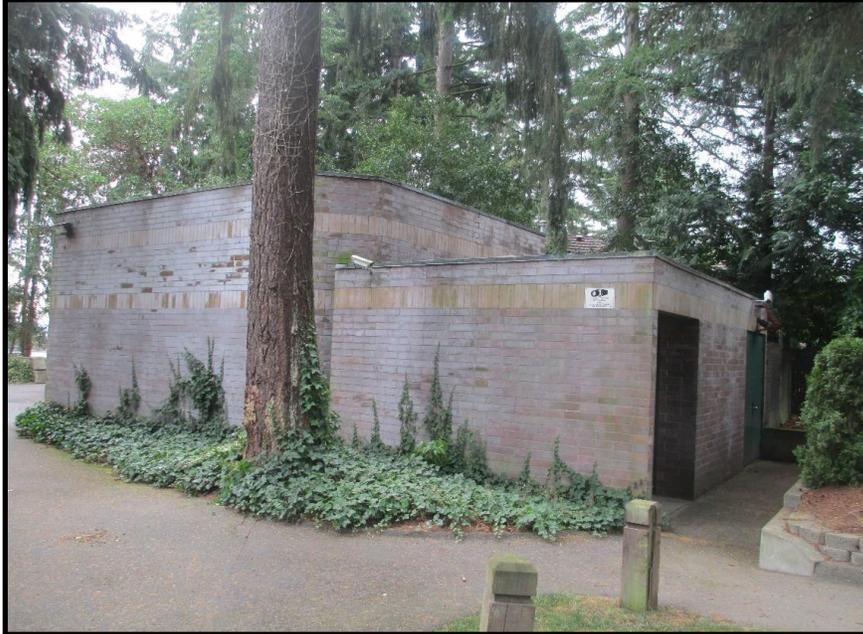
Photo 9: Maintenance Building - North Elevation

5. Out-of-plane brick masonry anchorage to the roof is deficient on all sides. The wall anchorage is required to prevent the masonry walls from pulling away from the roof.
RECOMMENDATION: Add strap anchors to connect the brick masonry walls to the roof at approximately 4' on-center.
6. There are no roof cross ties at the high roof in the east/west direction which reduces the factor of safety of the masonry walls pulling away from the roof.
RECOMMENDATION: Splice the 2x joist ends together where they bear on the glue-laminated beam.
7. Around the three skylights there is no reinforcement around the openings. There are high seismic stresses around these openings.
RECOMMENDATION: Add light gage straps over the sheathing on all sides of the skylights and extend approximately 2 feet past the openings.

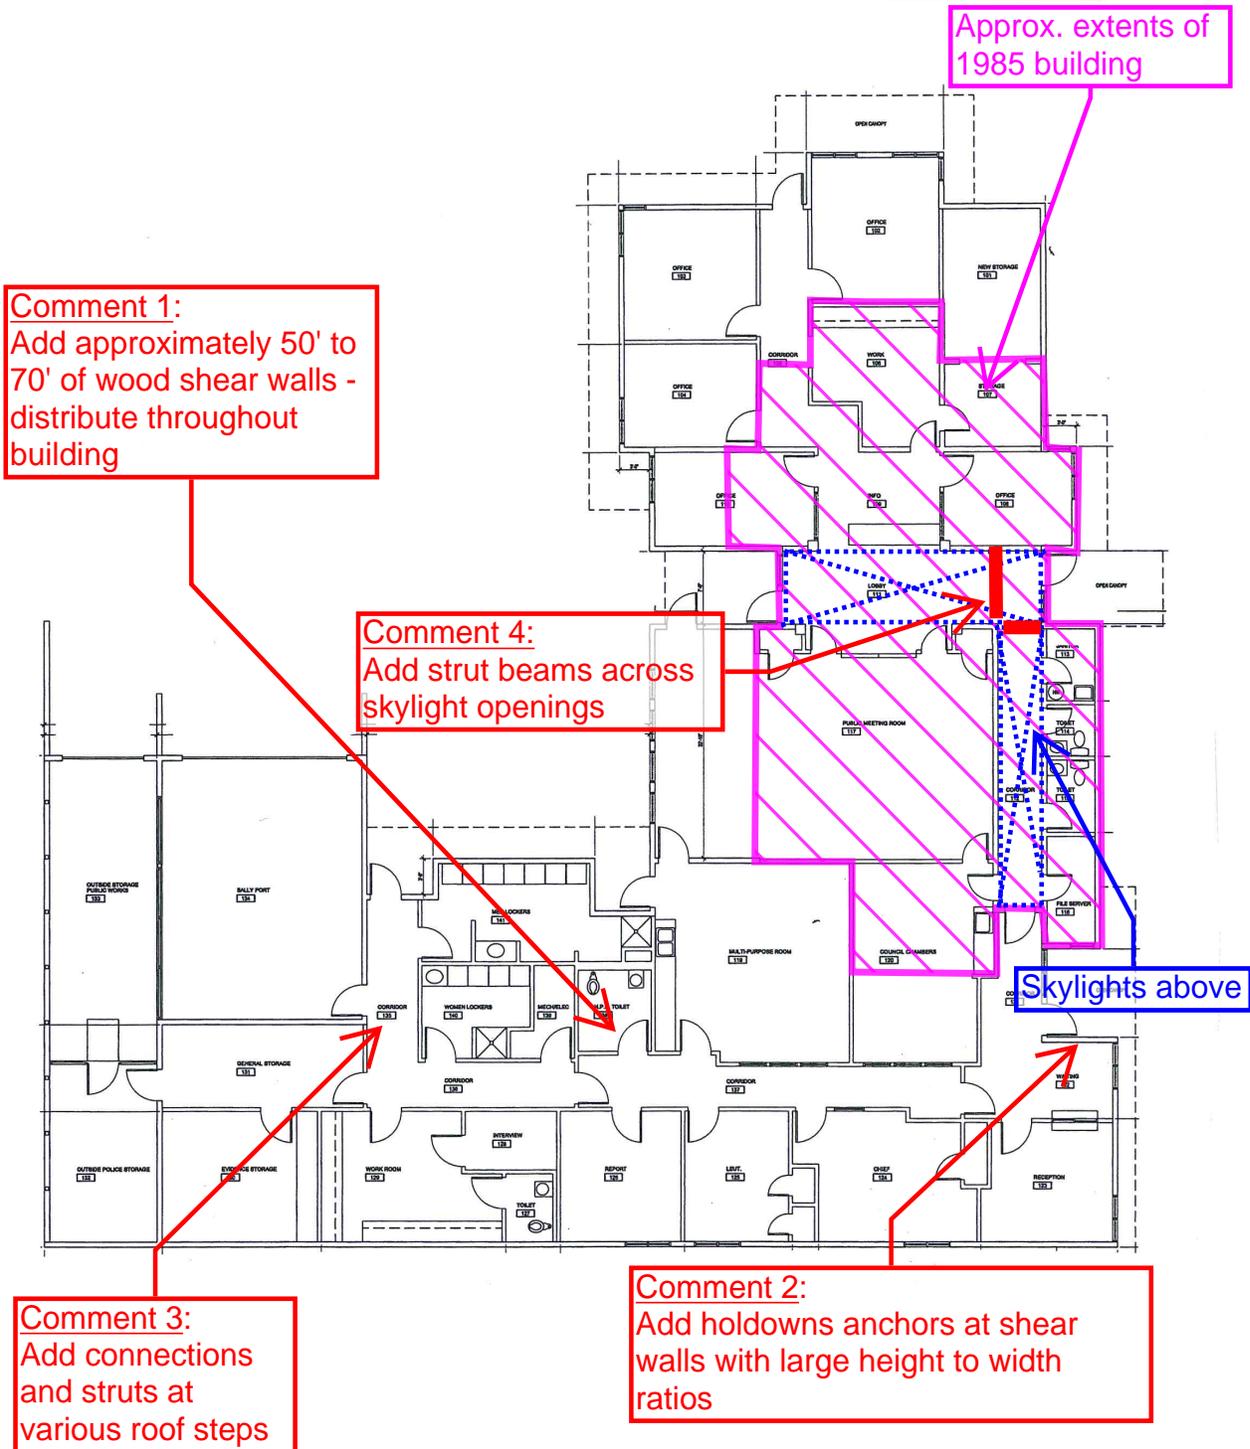
City Hall Floor Plan
Seismic Recommendations

1. The distribution of interior wood shear walls is not adequate to resist the seismic forces.
RECOMMENDATION: Approximately 50 to 70 feet of wood shear walls should be added to the building. Existing walls can be converted to shear walls by removing the gypsum wallboard and replacing it with plywood sheathing. The walls need to be anchored to the slab and connected to the roof diaphragm for a complete load path. Some foundation work could be required at the wall ends to accommodate wall holdown anchorage.

2. It appears from review of the existing drawings that the ends of the shear walls do not have holdown anchors to prevent the shear walls overturning during a seismic event. The overturning is a greater risk for walls with large height to width ratios.
RECOMMENDATION: Add holdown anchors at the shear walls with large height to width ratios. Assume approximately 10 to 16 holdown anchors need to be added. Some foundation work could be required to accommodate the anchorage of the holdown anchors.

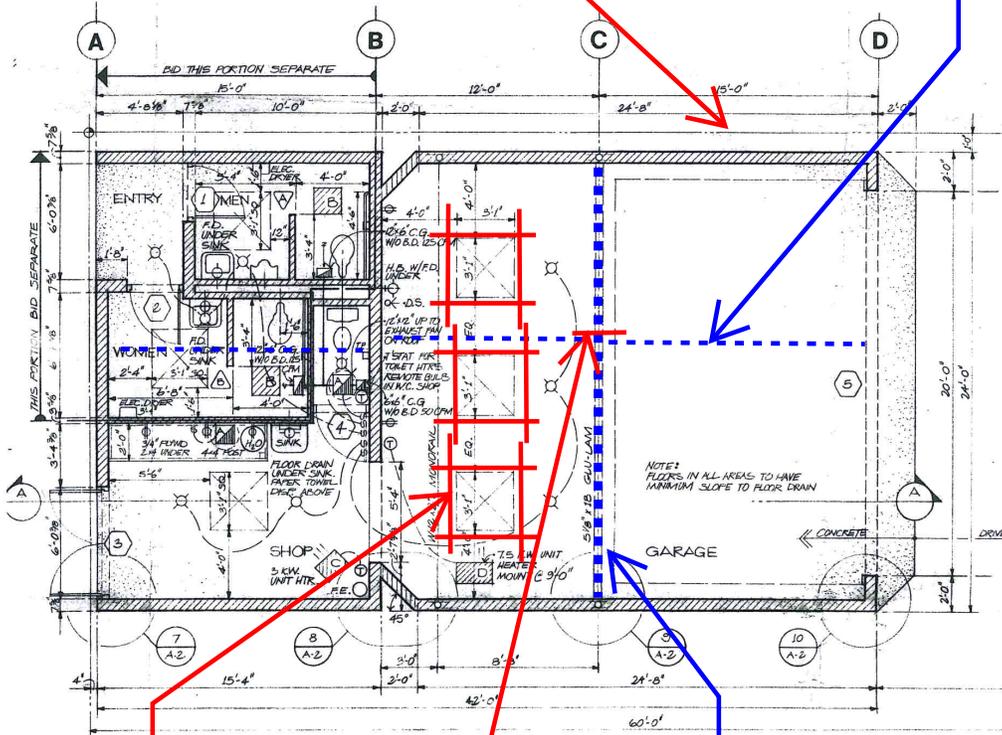
Maintenance Building Floor Plan
 Seismic Recommendations

Comment 5:
 Add roof
 out-of-plane strap
 anchors at 4'
 on-center around
 all walls

Comment 7:
 Strap around
 skylights

Comment 6:
 Strap roof joists
 together
