City of Clyde Hill
Council Study Session

3.1. Update of Property Evaluation on Fire Station #5
[Clyde Hill Facilities Assessment](#)

RE Clyde Hill
City Hall and Maintenance Building Existing Conditions Review

Mechanical Systems Survey

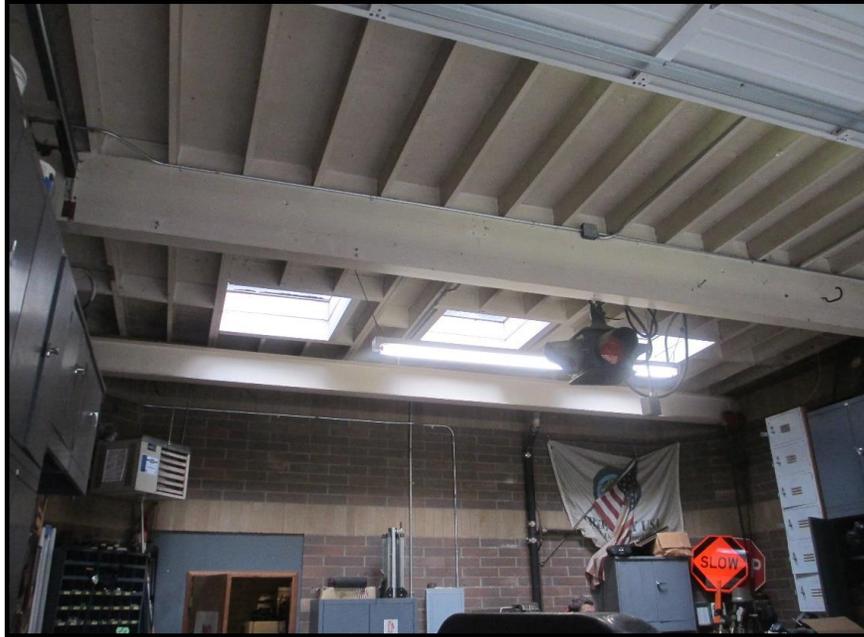
Photo 11: City Hall – Exposed Roof Framing

3. The roof diaphragm has many steps creating load path issues for the seismic forces.
RECOMMENDATION: Add additional connections and strut beams at roof steps to tie the building together better and distribute loads during a seismic event.
